## ALABAMA REGISTER OF LANDMARKS AND HERITAGE NOMINATION FORM

Historic: Charles M. Nelson House  
and/or Common: Mary Ann Nelson House

Charles M. Nelson House  
13232 Mary Ann Beach Road  
Fairhope, Al 36532

Renovation 2007

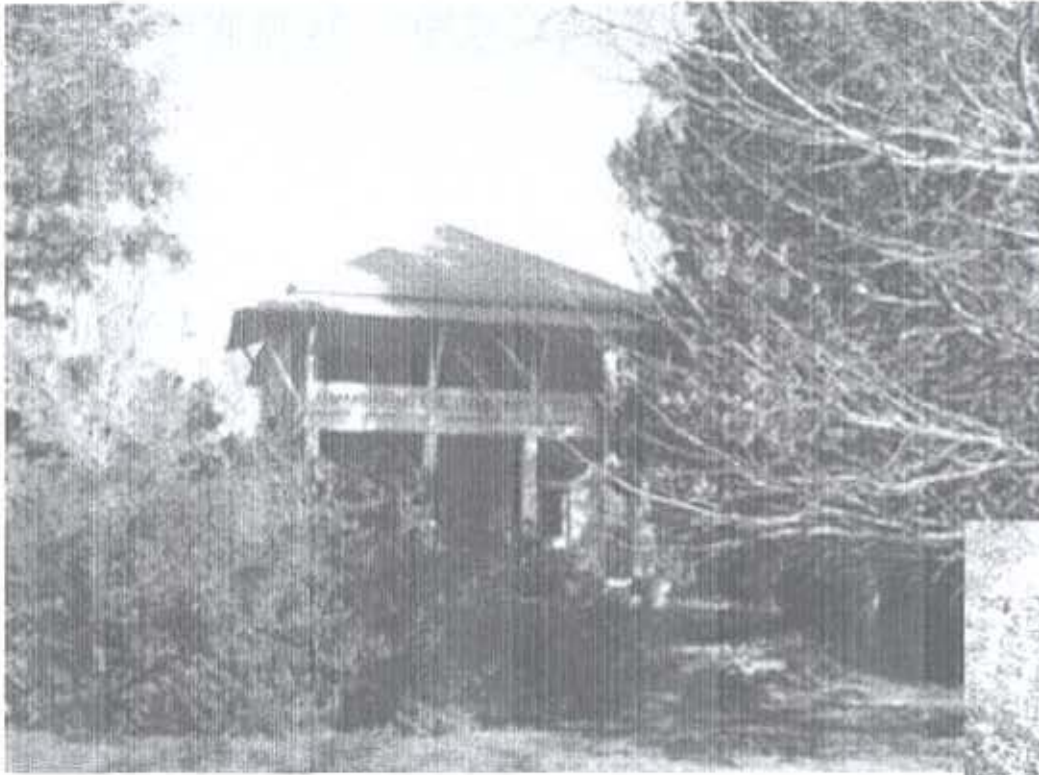
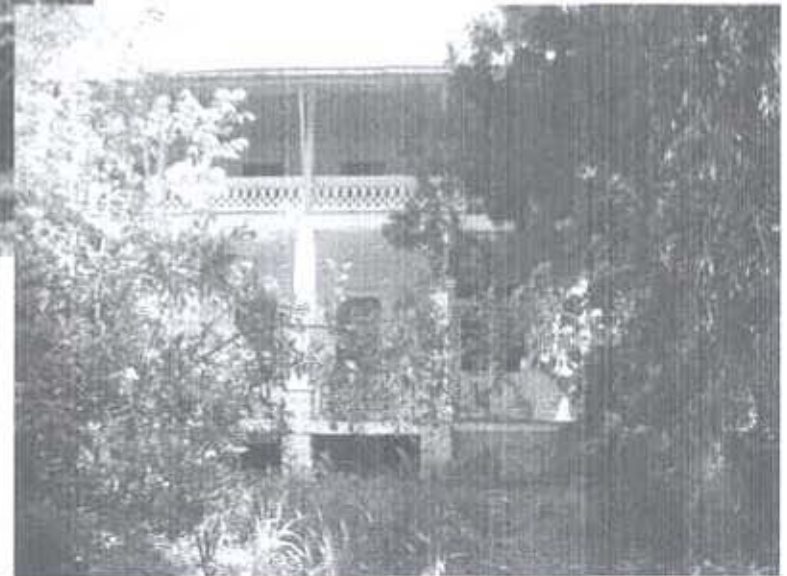
# Front Before

- b. Alterations- In 2007 the whole structure was in disrepair from neglect, water damage and termite damage. Although the house had residents I discovered severe structural damage to major components of the original house. During the repairs we noticed a few boards that had withstood the elements and were still intact. These were determined to be cypress, so we decided to use it exclusive for all repairs. All boards were true measured and rough cut, just like the original structure. Floors through out the first floor had severe termite damage that ran from the joist that had been spliced to beams with 2x4's. 6" beams had been replaced with 4" that were unable to hold the loads. We replaced all joist on the north side of the original structure and replaced the flooring with cypress. Walls were replaced with cypress bead board and tongue and groove. The entire kitchen was rebuilt and the original floor plan was followed.

Our mission in renovating this house was to repair the Structure so the building could endure through time and In the same process make it a livable house. All repairs were Made with true measured rough cut cypress lumber. The interior walls and floors were milled offsite but all chair rail and corner moldings were made on site.

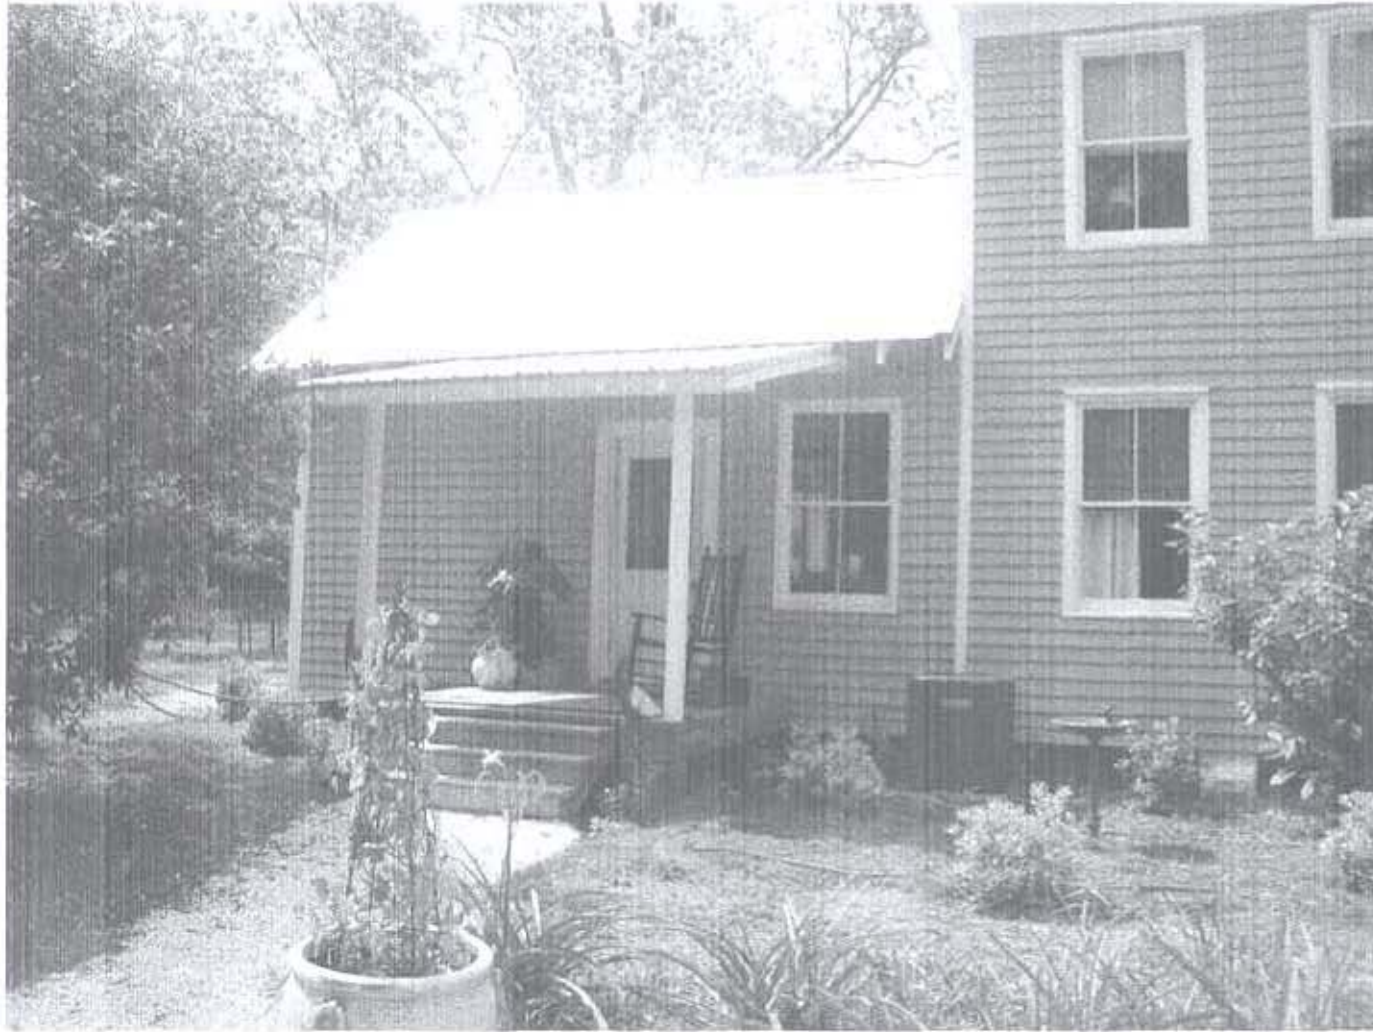
# Kitchen Entrance Finished

11. Doors- The main entrance is on the west side of the original house. It has a double door with a three light transom. Each pine door panel has glass with two panels below. The north side of the kitchen has a glass panel pine door with two raised wood panels below the interior side has detail trim. The south side entry to porch has a 8' double glass panel cypress door with two raised panels below. The west entrance to the master suite has the same door as the south porch entrance.

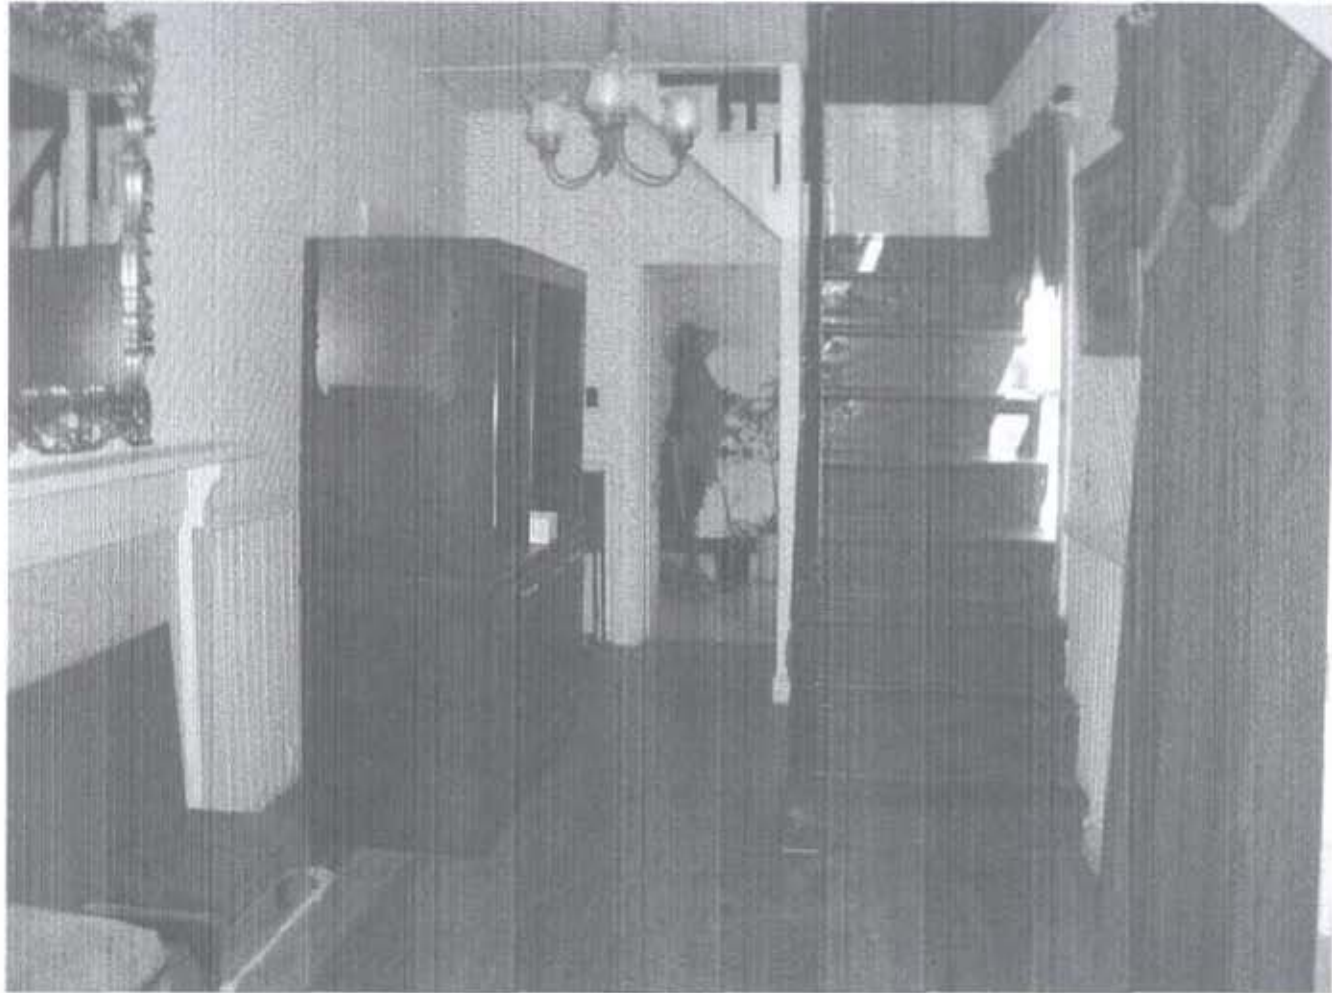
# Foyer Before

13. Interior features- Most interior features were in great disrepair due to water damage and termite damage. Walls, floors and chair rail were saved in the foyer. The upstairs' walls, ceilings and floors were saved. Original Mantels remain in the dining room and foyer. Dining room mantel is wood with mirror, the foyer is tile and wood.

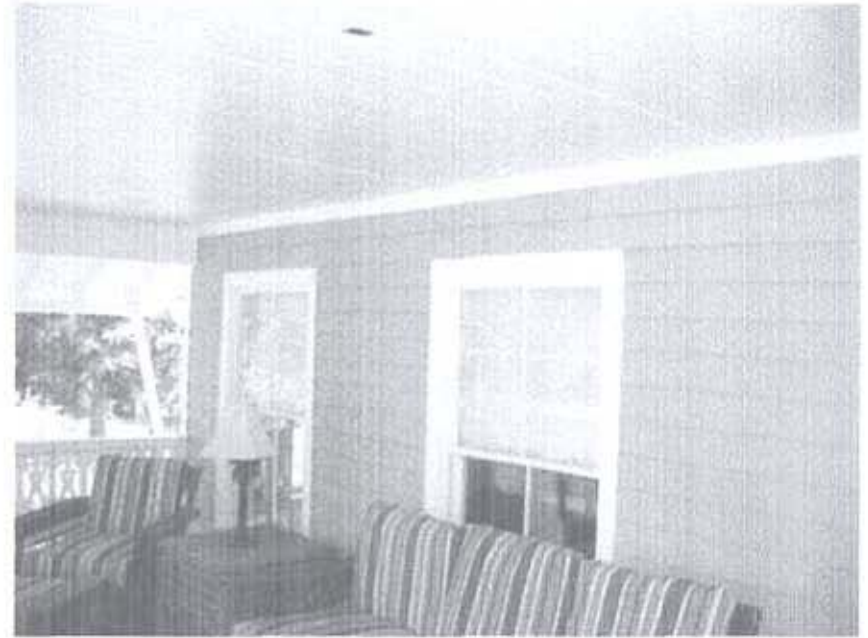
# Porches Finished

5. Exterior Wall Treatment-
6. Porches- The front of the original structure has two porches, one up and one main level. The size is 10'x25' each. They are covered by the front hip of the main roof. During restoration the rear kitchen revealed a porch off the south side and was rebuilt and screened. On the kitchens' north side it was discovered that entrance was an old fireplace. Due to the driveways location a porch was rebuilt 8'x8' with a plain leaning flat roof. An addition was done 2007 appx 16'x40' which has a porch on the front side that is covered by a hip roof beneath the gable of the addition.

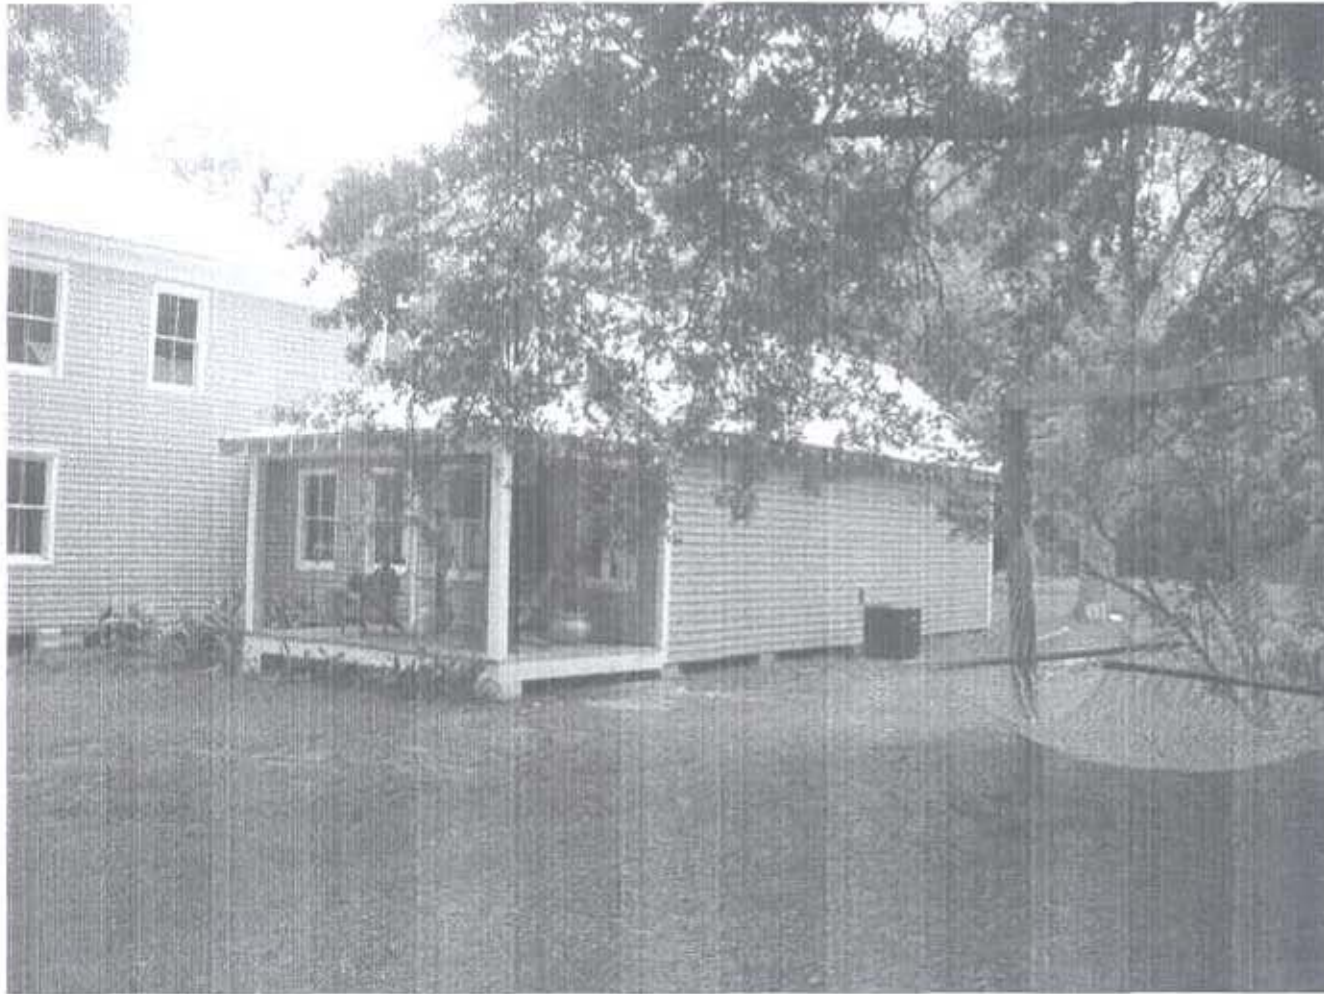
# The Addition

- a. Additions- master suite was added in 2007. This building lies on the south side of the original structure and connects to it by a hallway 14' long and 6' wide. Using the same type framing with the same size timbers duplicated the construction methods of the original structure. All chair rail trim was made on site and runs throughout the structure. There is no sub floor and true 1 1/2" thick cypress tongue and groove was used for flooring. All walls and ceilings are tongue and groove cypress, vertical bead board to chair rail and horizontal above chair rail.
