## ALABAMA REGISTER OF LANDMARKS AND HERITAGE Nomination Form

COUNTY Barbour County
NAME: Present COPELAND - REEVES Historic Former owner of property
LOCATION: Street and Number 404 West Broad Street
Town (Give directions if rural)Eufaula, Alabama
*A MAP WITH THE LANDMARK MARKED MUST BE SUBMITTED WITH THIS FORM*
CATEGORY: Building (X) Structure ( ) Object ( ) Site ( ) District ( )  USE: Present Single - Family Residential Historic Single - Family Residential
OWNERSHIP: Public ( ) Private (X )
Owner's Name Jesse Jones, M.D.
Mailing Address 404 West Broad Street
Eufaula, Alabama
INTEGRITY: Original Site (X) Moved () When?
From where? (Give details in significance.)
CONDITIONS: Excellent ( ) Good (x) Fair ( ) Ruins ( )
THREATS: No ( X) Yes ( ) By What?
RESTORATION WORK: Being considered (X) Underway () Completed () Not planned ()
SURROUNDING ENVIRONMENT: Open land ( ) Woodland ( ) Scattered buildings ( ) High building density ( ) Commercial ( ) Industrial ( ) Residential ( X ) Rural ( )

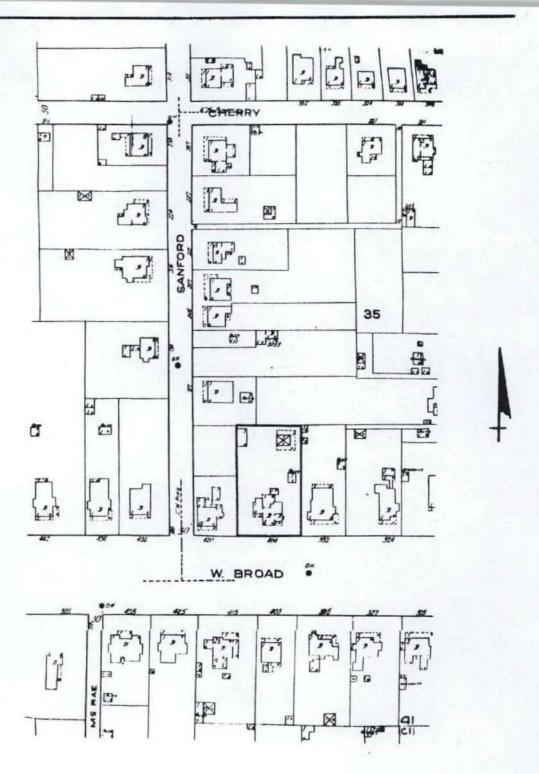
Shown in yellow is the COPELAND - REEVES HOUSE as it appeared on the Sanborn Fire Insurance Maps (commonly called "Sanborn Maps) of Eufaula, Alabama dated 1920.

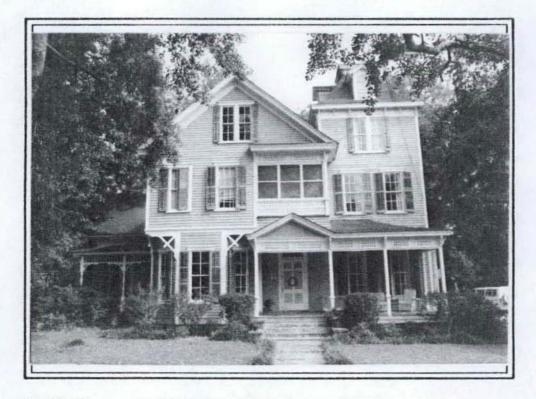
PHOTO NO. 1: FRONT ELEVATION SHOWING VICTORIAN DETAILS AND ENVIRONMENTAL SURROUNDINGS.

The structure is also the only three story "VICTORIAN" structure remaining in Eufaula. (SEE PHOTO NO. 1 - 5B)

The structure is identified as a three Story "VICTORIAN" house with brick foundation, wood frame construction, and clapboard wall material. The structure as viewed today displays the changes which has been made to the structure. (SEE PHOTO NO. 1 - 5B) The additions described previously are evident as one views the FRONT ELEVATION. The bedroom with porch was the first major addition. Displaying a gable roof this addition shows building materials common to the early 1900's. The chimney connected with this addition displays a tile design on the exterior. (SEE PHOTO NO. 5A) The REAR ELEVATION shows the additions which were made during the Post World War II ERA, All of these additions can be readily seen in the variation of the roof line from the original structure. (SEE PHOTO NO. 4) (SEE SITE PLAN) The structure displays a variety of Victorian ornamentation. (SEE PHOTO NO. 1 - 4 & 21, 22)

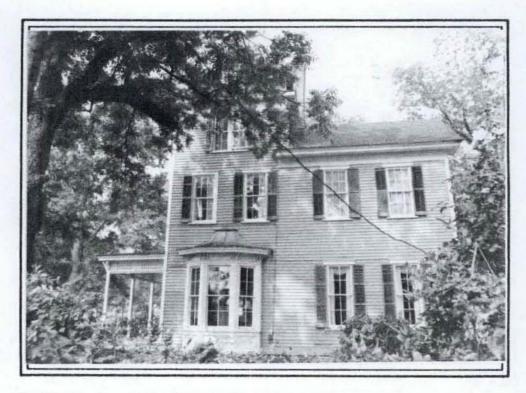
PHOTO NO. 2: EAST ELEVATION (SIDE ELEVATION) SHOWING WINDOW DETAIL, ROOF LINE, BAY WINDOW AND ENVIRONMENTAL SURROUNDINGS.

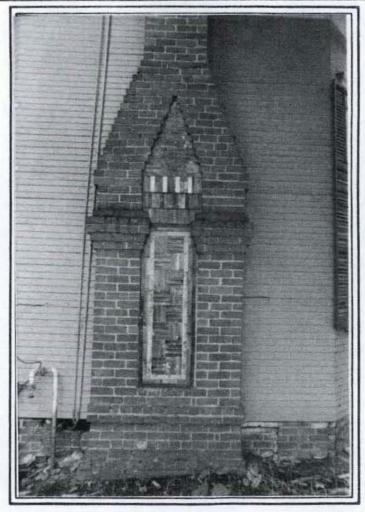
PHOTO NO. 5A: CHIMNEY DETAIL (EXTERIOR)

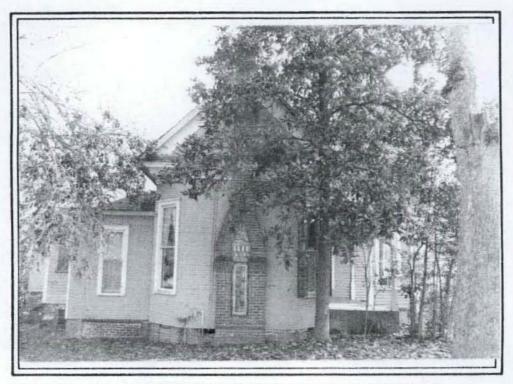
PHOTO NO. 5B : WEST ELEVATION SHOWING EXTERIOR DETAILS.
