ALABAMA REGISTER OF LANDMARKS AND HERITAGE Nomination Form

COUNTY Barbour County, Alabama
NAME: Present JOYCE - COPELAND - REEVES Historic Former owners of the property.
LOCATION: Street and Number 420 West Broad Street
Town (Give directions if rural) Eufaula , Alabama
A MAP WITH THE LANDMARK MARKED MUST BE SUBMITTED WITH THIS FORM
CATEGORY: Building (X) Structure () Object () Site () District ()
USE: Present Single - Family Residential Historic Single - Family Residential
OWNERSHIP: Public () Private (x)
Owner's Name Jesse Jones, M.D.
Mailing Address 404 West Broad Street
Eufaula, Alabama
INTEGRITY: Original Site (X) Moved () When?
From where? (Give details in significance.)
CONDITIONS: Excellent () Good () Fair (x) Ruins ()
THREATS: No (x) Yes () By What?
RESTORATION WORK: Being considered () Underway (X) Completed () Not planned ()
SURROUNDING ENVIRONMENT: Open land () Woodland () Scattered buildings () High building density () Commercial () Industrial () Residential (X) Rural ()

The JOYCE - COPELAND - REEVES HOUSE is located on the corner of West Broad Street and Stanford Avenue in Eufaula, Alabama. It was built by Mrs. E.C. Joyce, who acquired the property from Mr. J.C. Well

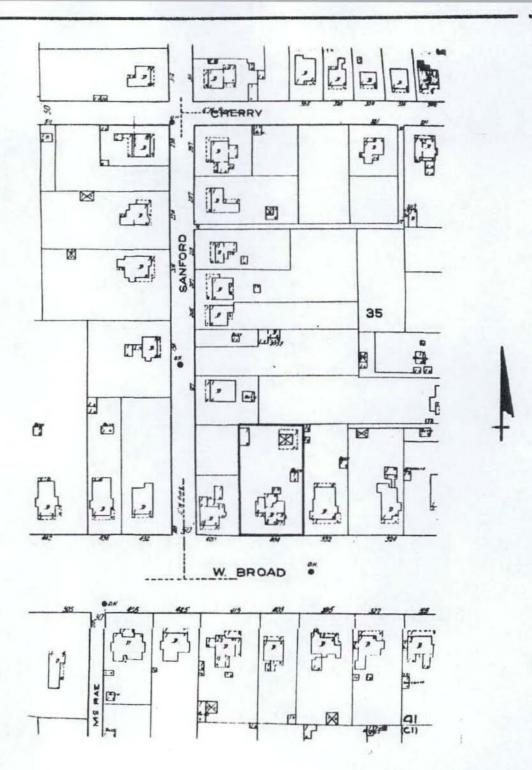
Shown in yellow is the COPELAND - REEVES HOUSE as it appeared on the Sanborn Fire Insurance Maps (commonly called "Sanborn Maps) of Eufaula, Alabama dated 1920.

This is evident in the variation of the roof line in comparison to the original structure. These alterations were made some time between 1873 and 1886 while Dr. Copeland lived in the house. The alterations do appear on the 1920 Sandborn Maps. (SEE PAGE 7) According to the Sandborn Maps there were no out-buildings on this lot. In so far as the surrounding are concern there does exist several large oak and pecan trees on the site and for the most part the environment has not changed severely over the years. (SEE SITE PLAN FOR FURTHER DETAIL)

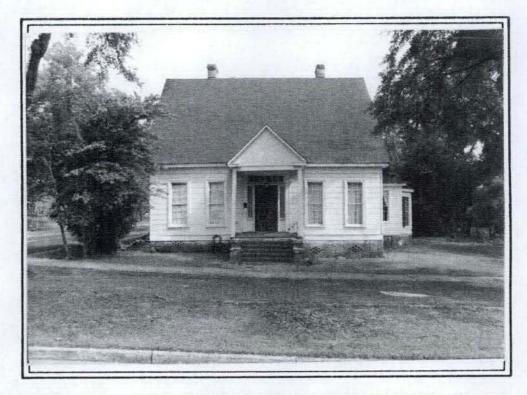
PHOTO NO. 1: FRONT ELEVATION SHOWING EXTERIOR DETAIL AND THE ENVIRONMENTAL SURROUNDINGS.

ESCRIPTION	(Continued)
Roof Type	(Gable, Gambrel, Mansard, Flat, Hipped, Combination) (SEE PHOTO NO. 1 - 5)
Roof Cover	ring: (Wood shingle, <u>Asphalt</u> , Tile, Metal, Slate)
Roof Trim	(Cornices, bargeboard, brackets, etc.)
Porches:	Front (type and description) Seven steps up to a covered stoop (GABLE)

The structure is described as a GREEK REVIVAL COTTAGE with gable roof, brick foundation and clapboard wall covering. The house is built of wood frame construction and exteriorly the structure is in fair condition. The structure as viewed today displays the changes that have been made over the years. The additions as described previously are the bathroom area or space 7, the baywindow area or space 5 and the kitchen area or space 6. Alterations to the structure are basically those of modernizing however, this structure originally displayed a porch which extended the entire length of the front elevation. For the most part the structure still reflects its original materials and integrity. (SEE PHOTO NO. 1 - 19)

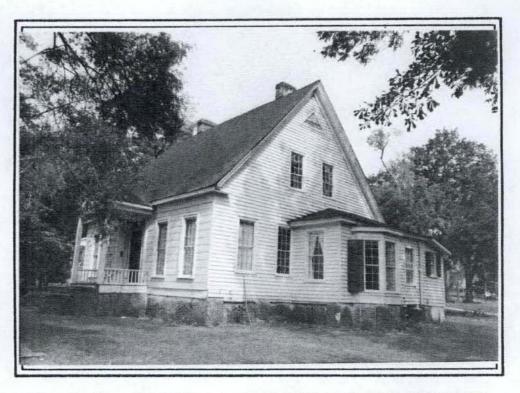
PHOTO NO. 2: PERSPECTIVE SHOWING FRONT AND EAST ELEVATIONS AND THE ENVIRONMENTAL SURROUNDINGS.

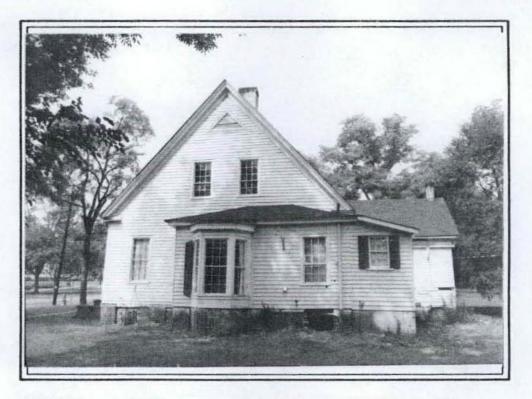
PHOTO NO. 3: EAST ELEVATION SHOWING BAY WINDOW AND THE ENVIRONMENTAL; SURROUNDINGS.

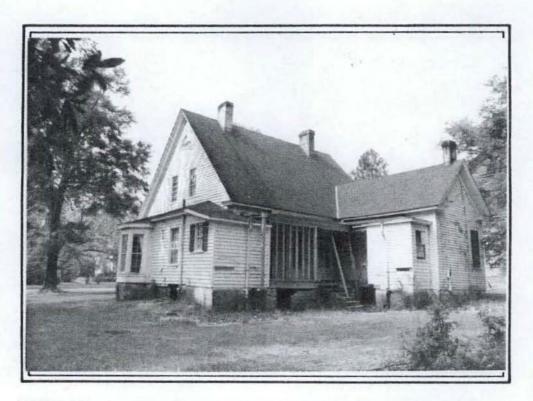
PHOTO NO. 4: REAR ELEVATION SHOWING EXTERIOR ALTERATIONS.

11.5'X 7' brick foundation with wooden sills and wooden floor boards.
	Rear (type and description) Recessed rear porch beneath partially flat
	roof porch is "L" shaped 24' X 6'. (SEE PHOTO NO. 4)
	Side (type and description) N/A
Ot	in entrance (location, description) Located on FRONT ELEVATION the door is double panelled with arch, with sidelights and transom. (SEE PHOTO NO. 7) there entrances (location, description) There are three alternate entrance off of the rear porch all of which are four panelled doors. (SEE PHOTO NO. 6 FOR REPRESENTATIVE SAMPLE) Types and number of each floor of facade
	Types and number per floor for sides and rear (FOR WINDOW DESCRIPTION SEE PAGE)
Other: Us	Describe mantels, stairways, wainscoting, plasterwork and any unusual feature. The flooring in all original rooms is 5" tounge and groove heart pine. Flooring in the later additions is 5" tounge and groove flooring. (SEE PHOTO NO. 8 - 19) The origina- material for the wall covering was plaster on lath with open loft. Ceiling finish was also plaster over lath. Hardware for the most part is not original with the structure. Most of the door and window hardware has either been replaced or removed. (SEE PHOTO NO. 9 &11) There are four mantels on the first floor all of which are wooden with the exception of the mantel in SPACE 2 which is a cast iron mantel. (SEE PHOTO NO. 9 - 13) (CONTINUED) this space to describe any additions, alterations, outbuildings or other eatures of the structure and its surroundings.

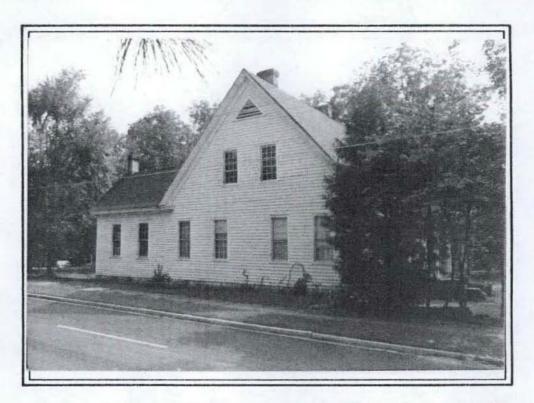
PHOTO NO. 5: WEST ELEVATION FROM SANDFORD STREET SHOWING THE EXTERIOR DETAILS AND ALSO THE SIDEWALK.

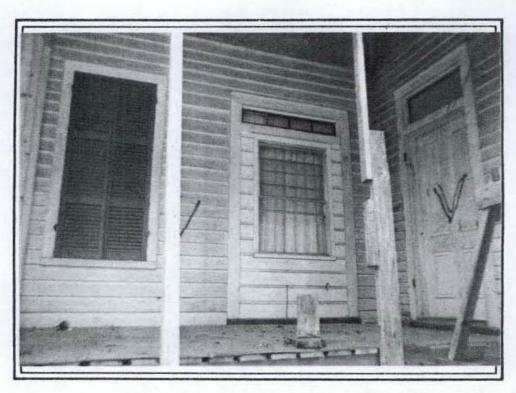
PHOTO NO. 6: EXTERIOR DETAIL SHOWING THE ALTERATION OF THE ORIGINAL DOORWAY TO THE BOXING IN OF A WINDOW.

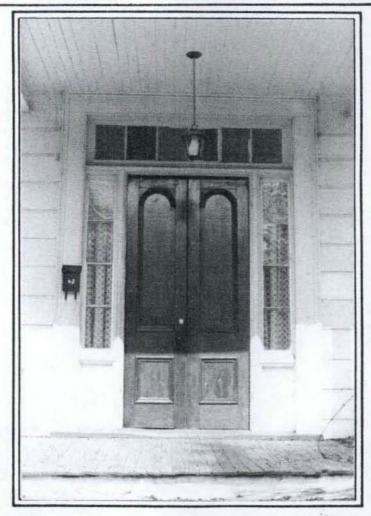
PHOTO NO. 7 : FRONT ELEVATION MAIN ENTRANCE.

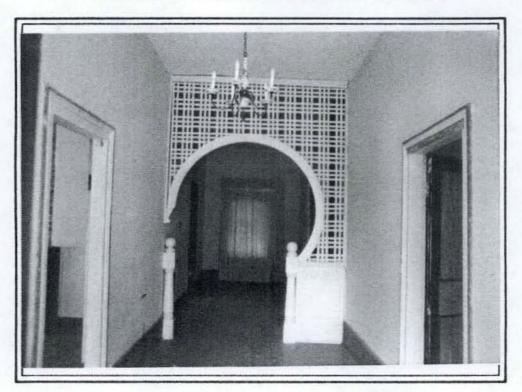
PHOTO NO. 8 : INTERIOR DETAIL SHOWING HALL DIVIDER.
