### State Historic Preservation Office Preliminary Information Form

#### Harmon Farmhouse

34034 US Highway 431, Welch Community, Chambers County

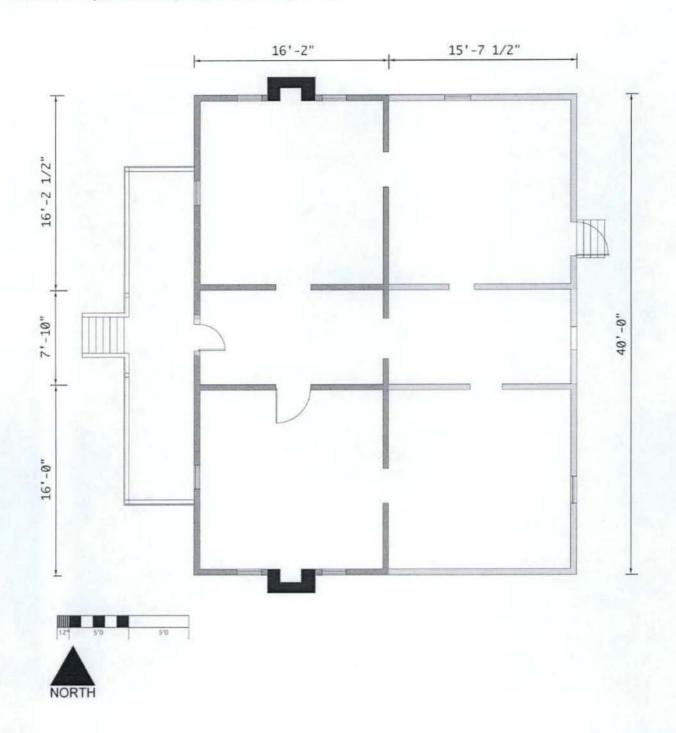
## FIRST FLOOR PLAN

Scaled Drawing, Electronically Reduced, See Graphic Scale

The interior plan of the core consists of a formerly open dogtrot flanked to either side by single rooms. The rear shed extensions each contain a single room separated by an extension to the dogtrot. The southern room has an exposed ceiling and exposed walls. Remaining rooms have flush tongue and groove board ceiling and wall finishes. Interior walls at the dogtrot are finished with weatherboard siding. Wood floors are exposed throughout. Each of the rooms at the core retains a simple wood mantelpiece.

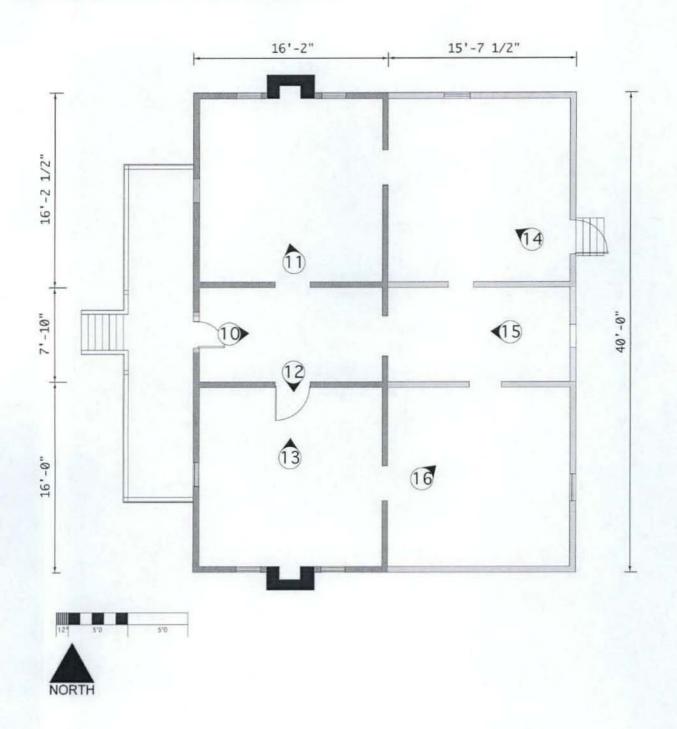
## FIRST FLOOR PLAN

Scaled Drawing, Electronically Reduced, See Graphic Scale
