## ALABAMA REGISTER OF LANDMARKS AND HERITAGE NOMINATION FORM

The Gibeon Jefferson Sullivan Cabin  
The G G House

### SULLIVAN CABIN

nr. Wagarville, Washington County, Alabama

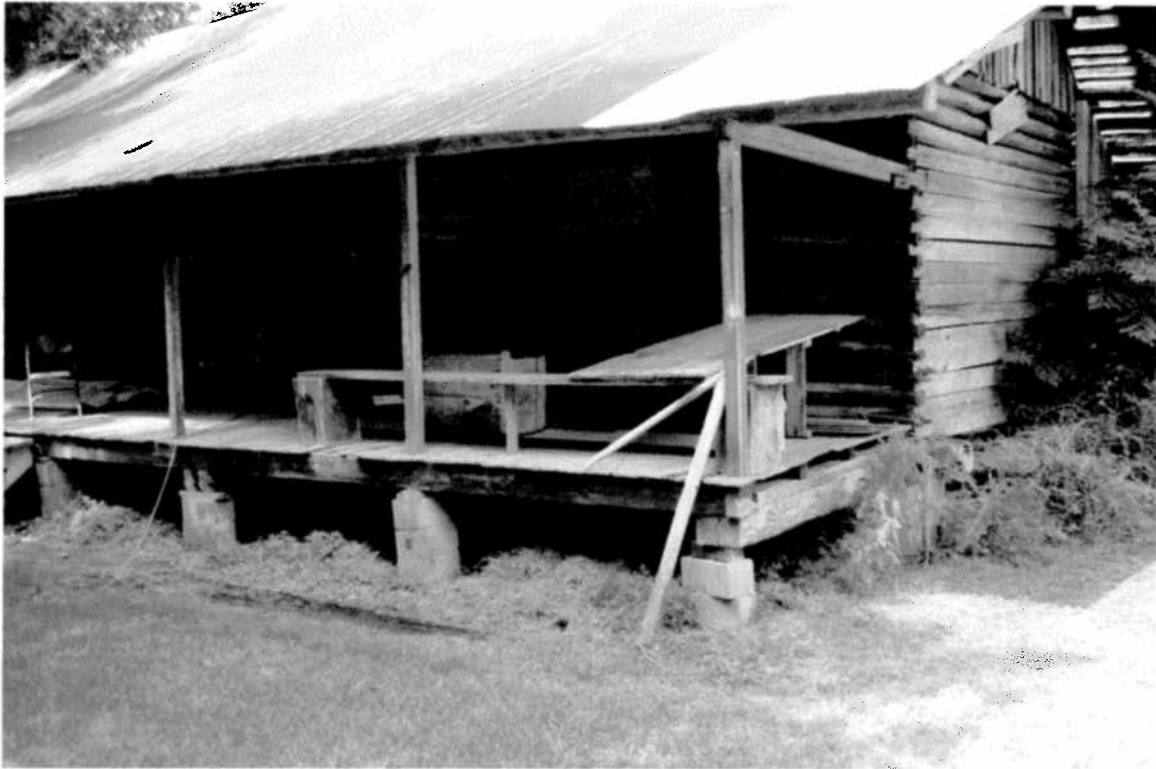
Note: the wide flat slanted wooden board on the (north) end of the porch of the Sullivan Cabin. This board is called a "cooling board." Before the days of mortuaries and professional undertakers, Gibeon Sullivan often performed this service for his neighbors. The corpse was laid out to "cool" on the board and then the body bathed and dressed for burial. The cooling board is notched underneath so it can be lifted and set across a wagon bed. The notches kept the board from sliding as the wagon moved. *This is the original cooling board used by Gibeon Sullivan.*

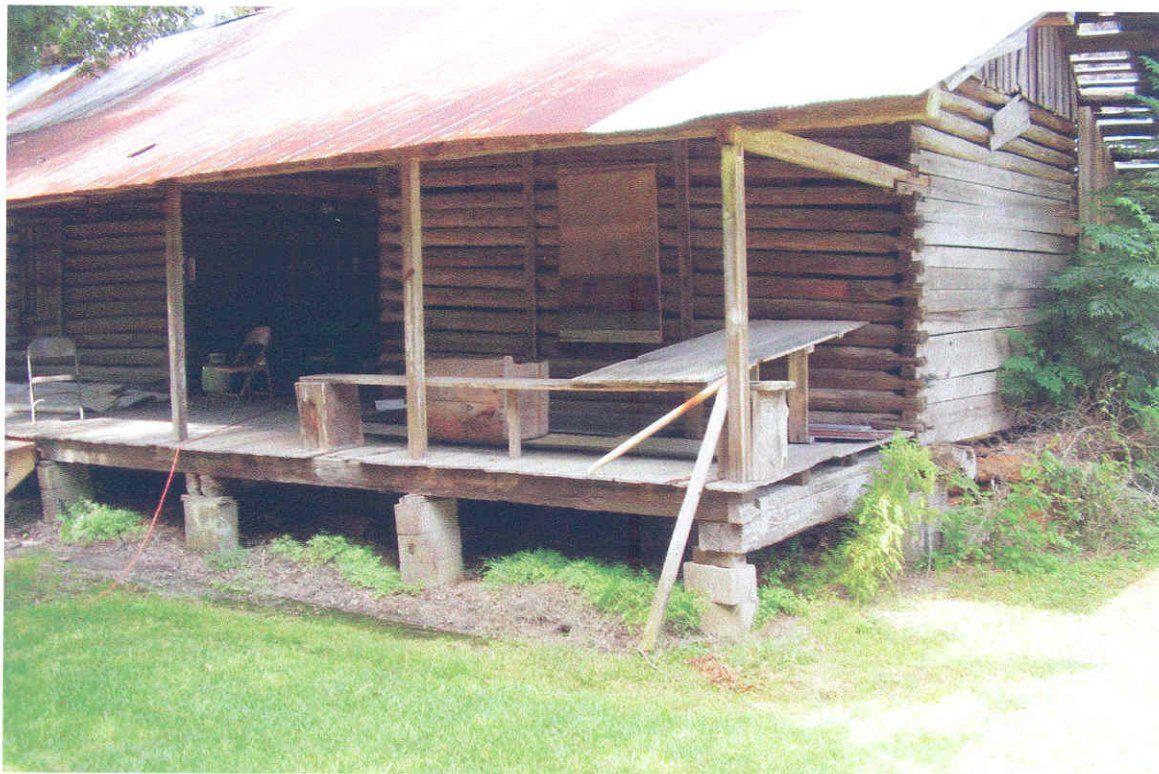
Note: the wide flat slanted wooden board on the (north) end of the porch of the Sullivan Cabin. This board is called a "cooling board." Before the days of mortuaries and professional undertakers, Gibeon Sullivan often performed this service for his neighbors. The corpse was laid out to "cool" on the board and then the body bathed and dressed for burial. The cooling board is notched underneath so it can be lifted and set across a wagon bed. The notches kept the board from sliding as the wagon moved. *This is the original cooling board used by Gibeon Sullivan.*
